# **General Aviation Airworthiness Alerts**

**AC No. 43-16**

**ALERT NO. 217  
AUGUST 1996**

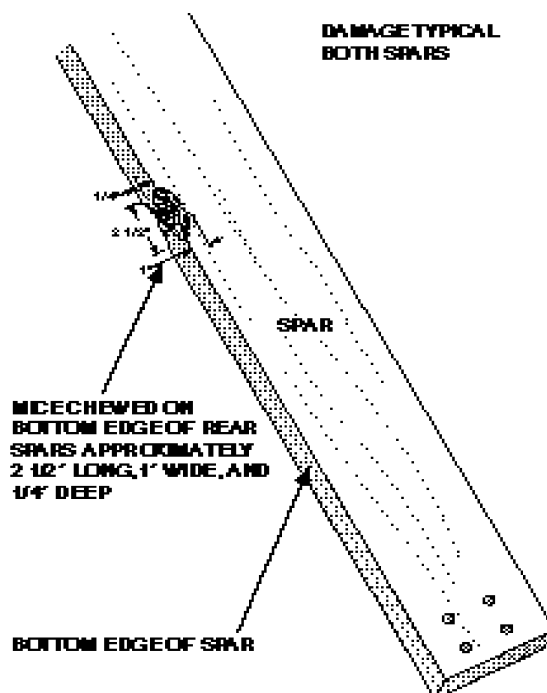
After removing the fabric covering from the left and right wings, damage was found on both of the rear spars.

The damage was located approximately half-way between the wing root and the strut attachment fitting. The submitter stated the damage was caused by "mice" chewing on the wood spars. (Refer to the following illustration.) The "chew marks" had a coat of varnish covering them which indicated the damage existed when the wings were covered in 1982. The extent of this damage required replacement of both rear spars.

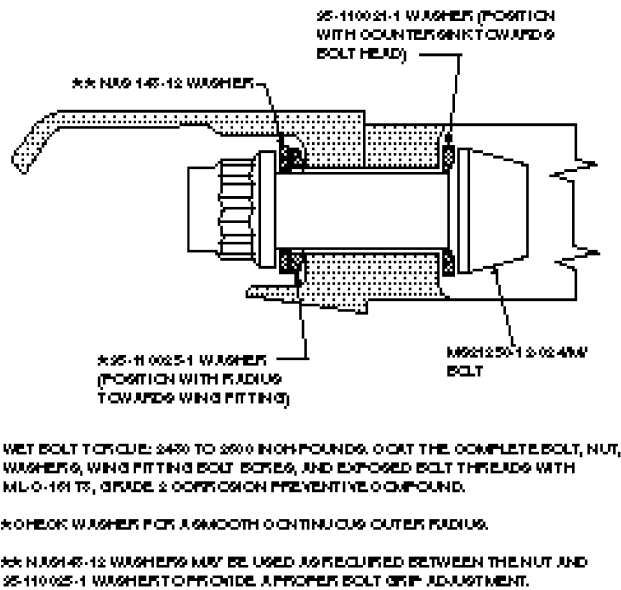
While performing a 5-year wingbolt and fitting inspection, improper hardware was found installed.

At some point, both the left and right lower aft radius washers (P/N 95-110025-1) were replaced with washers (P/N NAS 143-12) which were not beveled on the outer edge. (Refer to the following illustration.) When the wing attachment bolts were torqued, the outer edge of these washers cut into the radius of the wing attachment fittings (P/N's 95-110017-1, left and 95-110017-2,

right). Care should be taken during assembly to ensure the correct parts are installed in the proper order.

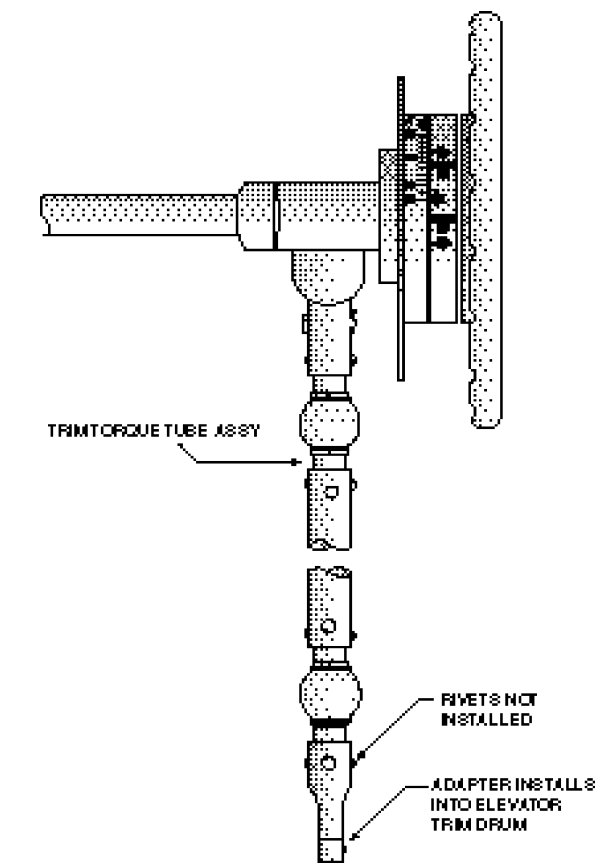
An investigation revealed that two rivets were missing from the elevator trim torque tube assembly (P/N 43083-818-2) where it should have been attached to the lower universal drive adapter. (Refer to the following illustration.) This allowed the shaft to turn inside the tube assembly; however, the elevator cable drum was not driven. Since there was no evidence that these two rivets had ever been installed, the submitter speculated they had been omitted during assembly of the aircraft.

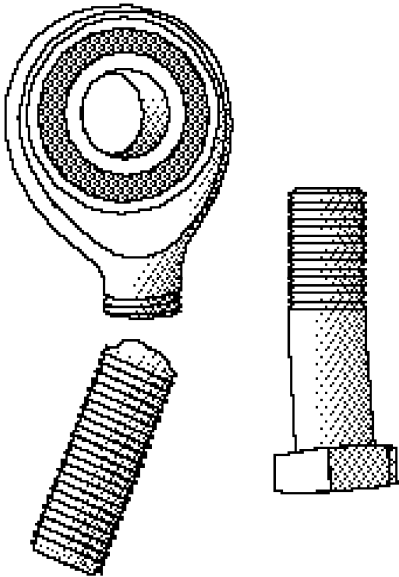
An investigation revealed the nose landing gear actuator rod-end (P/N 452-853) was broken, and allowed the nose gear to collapse. (Refer to the following illustration.) Visual inspection of the rod-end fracture surface disclosed features typical of bending overload and instantaneous ductile failure. The rod-end had bent approximately 10 degrees before failure occurred. An inspection of the actuator-to-fuselage attachment bolt (P/N 401-508) revealed it was deformed from shear loading between the actuator and the fuselage attachment point.
